ADDENDUM 2 TO GEN-07-ASAM-04

2-9 INSPECTION CRITERIA FOR IMAGE INTENSIFIER OPERATION

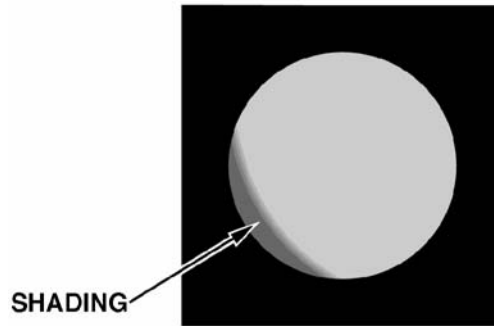
Figure 2-1. Shading.

(1) Shading. Each monocular should present a circular image. If shading is present, you will not see a fully circular image (Figure 2-1). Shading is indicative of a dying photocathode caused by a defective vacuum seal on the image intensifier. Shading is very dark and you cannot see an image through it. Shading always begins at the edge and migrates inward eventually across the entire image area. Shading is a high contrast area with a distinct line of demarcation. Do not confuse shading with variations in output brightness – refer to paragraph 2-9c(6). If shading is present, the image intensifier assembly must be replaced by AVIM.

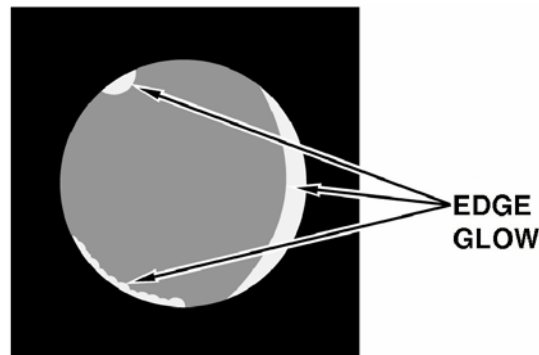
Figure 2-2. Edge Glow.

(2) Edge Glow. Edge glow is a bright area (sometimes sparkling) in the outer portion of the viewing area (Figure 2-2). Edge glow is sometimes caused by an emission point (or series of emission points) just outside the field of view or by a defective phosphor screen that permits light feedback to the photocathode. To check for edge glow, remove the binocular from the test ports (keeping the goggle connector attached) and block out all light by cupping a hand over the lens. If the image tube is displaying edge glow, the bright area will still show up. If edge glow is present, record this specific defect on the maintenance forms. The image intensifier assembly must be replaced by AVIM.

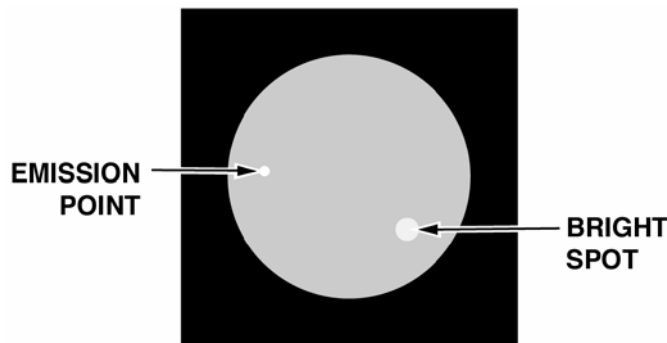
Figure 2-3. Bright Spots and Emission Points.

(4) Emission Points. A steady or fluctuating pinpoint of bright light in the image area that does not go away when all light is blocked from the objective lens of that monocular (see Figure 2-3). The position of an emission point within the image area does not move. If a bright spot remains when you cup your hands over the objective lens (subparagraph 2-9c(1) below), place the goggles onto the TS-3895A/UV test set and

turn the selector knob to LOW LIGHT and note the point's location. Then turn the selector knob to HIGH LIGHT. If the emission point still exists and the tube is still under warranty, remove and return for warranty repair/replacement per paragraph 1-7.

(1) **Bright Spots.** These are signal-induced blemishes in the image area caused by a flaw in the film on the MCP. A bright spot is a small, nonuniform, bright area that may flicker or appear constant (Figure 2-3). Not all bright spots make an image intensifier rejectable. Remove the binocular from the test ports (keeping the goggle connector attached if using the TS-3895A/UV) and cup your hand over the lens to block out all light. If the spot remains, it is an emission point; refer to subparagraph 2-9b(4) above for evaluation. If the spot disappears, it is a bright spot. Place the goggles onto the TS-3895A/UV test set and turn the selector knob to HIGH LIGHT for 15 seconds and note the spot's location. Turn the selector knob to LOW LIGHT and wait another 15 seconds. If the spot disappears or is faintly visible, it is acceptable. If the spot interferes with the ability to perform the mission, AVIM must replace the image intensifier.

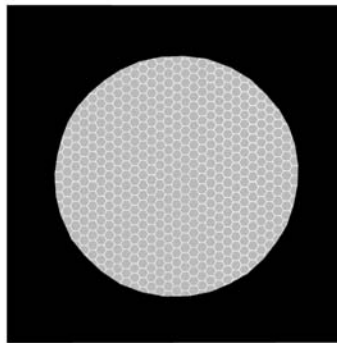
Figure 2-4. Fixed-Pattern Noise.

(3) **Fixed-Pattern Noise (Honeycomb).** This is a cosmetic blemish characterized by a faint hexagonal pattern throughout the viewing area that most often occurs at high light levels or when viewing very bright lights (Figure 2-4). This pattern can be seen in every image intensifier if the light level is high enough. This condition is acceptable as long as you can resolve the resolution target at the high light level. If it still remains when viewing at the low light level, AVIM must replace the image intensifier assembly.

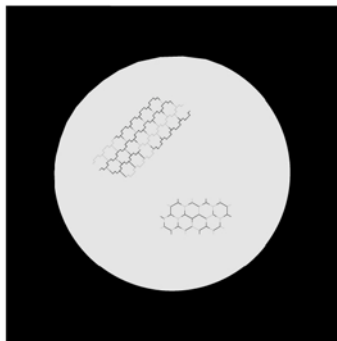
Figure 2-5. Chicken Wire.

(4) **Chicken Wire.** An irregular pattern of dark thin lines in the field of view either throughout the image area or in parts of the image area (Figure 2-5). Under the worst case condition, these lines will form hexagonal or square-wave shaped patterns. These lines are caused by defective fibers that do not transmit light occurring at the boundaries of fiber bundles in the output optic of the image intensifier. No action is required if this condition is present unless the chicken wire is deemed excessive by the user and the appropriate maintenance forms and records are completed in accordance with DA Pam 738-751. In which case, AVIM must evaluate the system for further action.
